Imaging of prosthetic joints

S OSTLERE, FRCR and S SOIN, MB BChir

Nuffield Orthopaedic Centre and Oxford Radcliffe Hospital, Oxford, UK

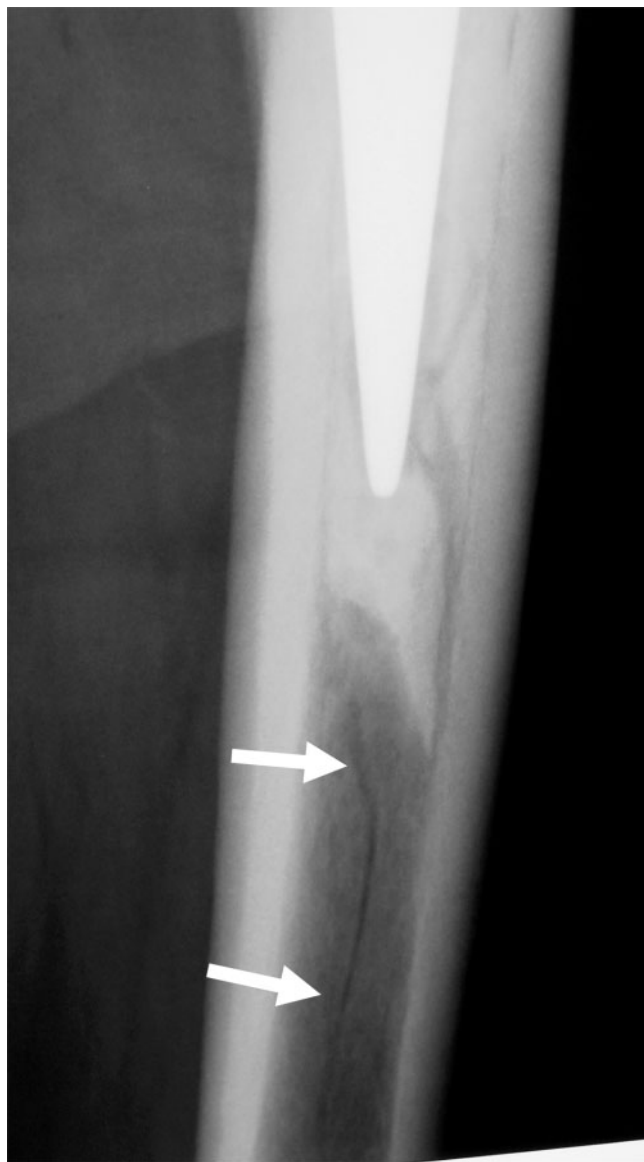
Figure 1. Periprosthetic fracture. The tip of the prosthesis has breached the cortex of the femur (arrows).

In the immediate post operative period a plain film is routinely performed. The position of the femoral prosthesis should be noted. An excessively varus stem may predispose to loosening. Periprosthetic fracture may be seen particularly in revision prostheses and patients with poor bone stock (Figure 1). Dislocation is a common early complication with an incidence of approximately 3% (Figure 2).

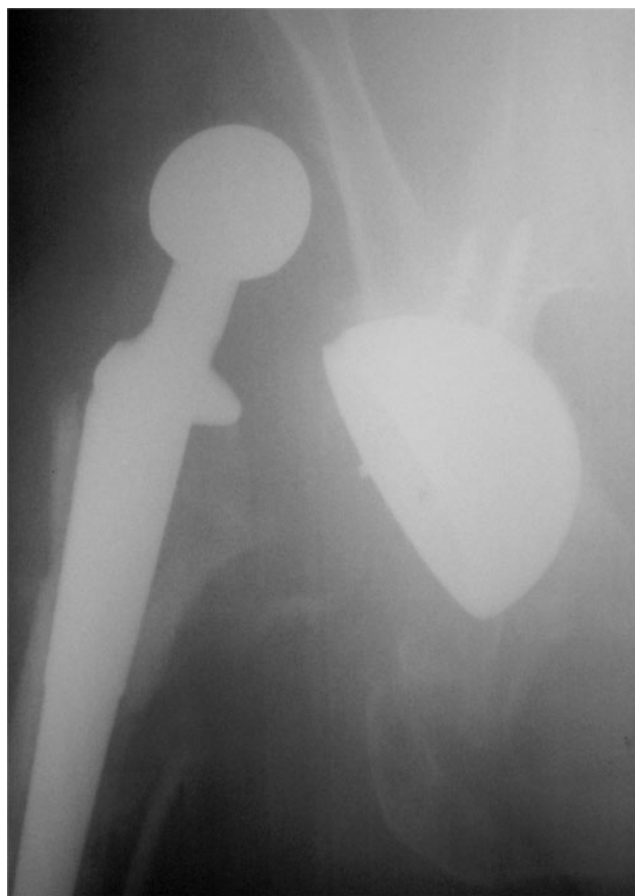
Figure 2. Dislocation of the hip joint soon after surgery.

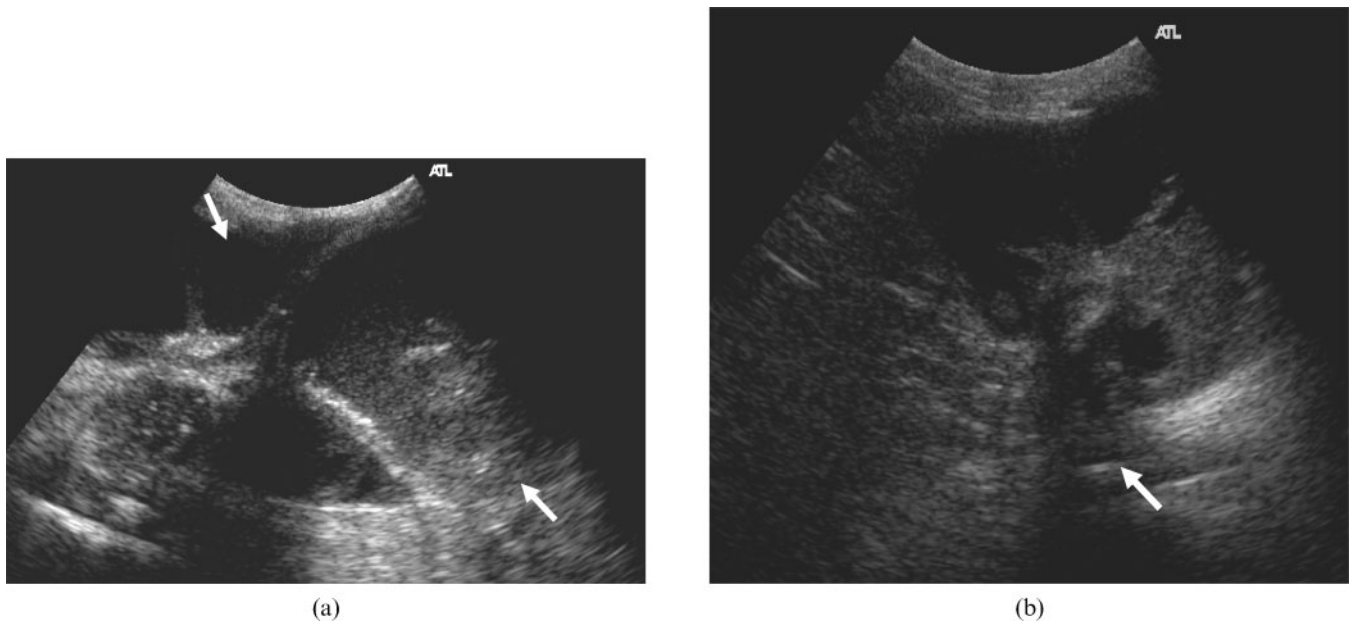
Figure 3. Ultrasound of an infected hip. (a) There is a large multilocular collection with an echogenic component (arrows). (b) The collection lies just deep to the scar but is seen to extend down to the neck of the femoral component which appears as a well defined echogenic line (arrow).

Early post-operative haematoma and infection are quite common. Ultrasound is an excellent technique for identifying soft tissue collections and guiding aspiration in these cases. Ultrasound can also usually determine whether a superficial collection communicates with the hip joint or not (Figure 3). MRI will often provide better anatomical detail for pre-operative planning in extensive deep collections although the portion of the image adjacent to the prosthesis will be degraded by metal artefact.

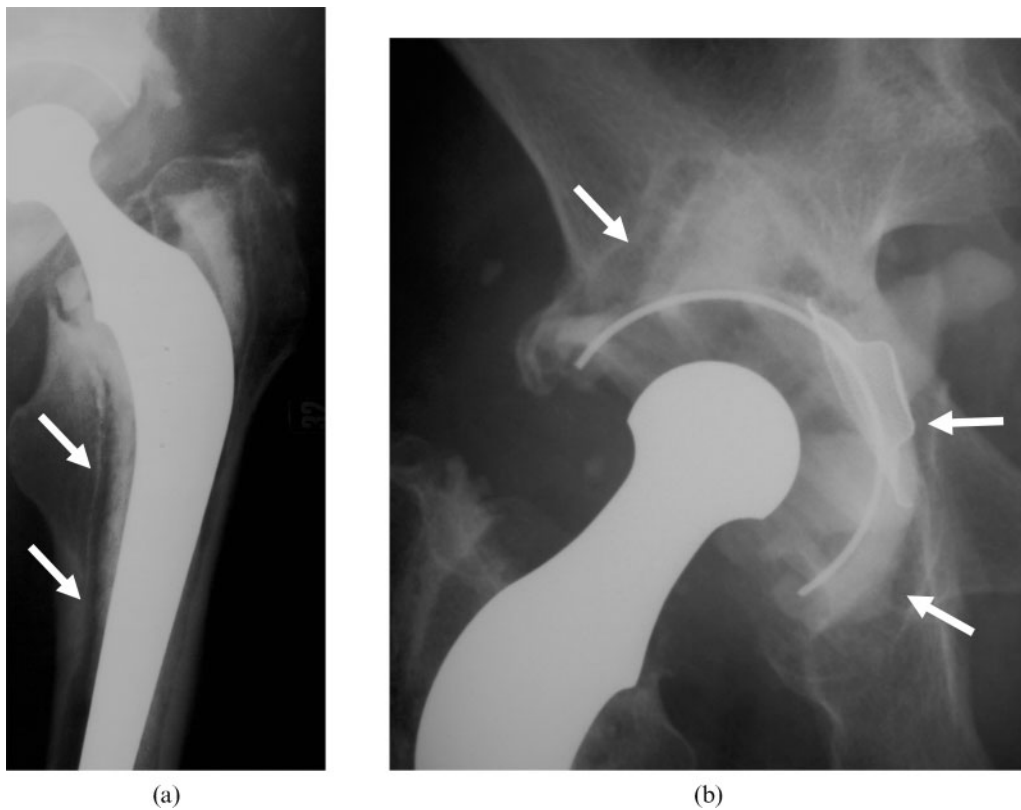
Figure 4. Loose cemented prostheses. Wide extensive lucency at the bone/cement interface is seen at (a) a femoral and (b) an acetabular component (arrows).

wider and more extensive the lucency, the more probable the component will be found to be loose at surgery (Figure 4). There are no hard radiological rules for diagnosing loosening but stem or cement fracture, 5 mm of subsidence, progressive radiolucency at the bone-cement interface or lucency 2 mm wide or greater than 50% of the interface have been quoted as criteria for femoral stem loosening (Figures 5-7) [1]. The significance of lucency around the acetabular component is less certain. It is generally accepted that a stable lucency of less than 2 mm at the bone-cement interface may be seen with loosening. Lucencies involving only part of the acetabular bone cement interface are also of doubtful significance.

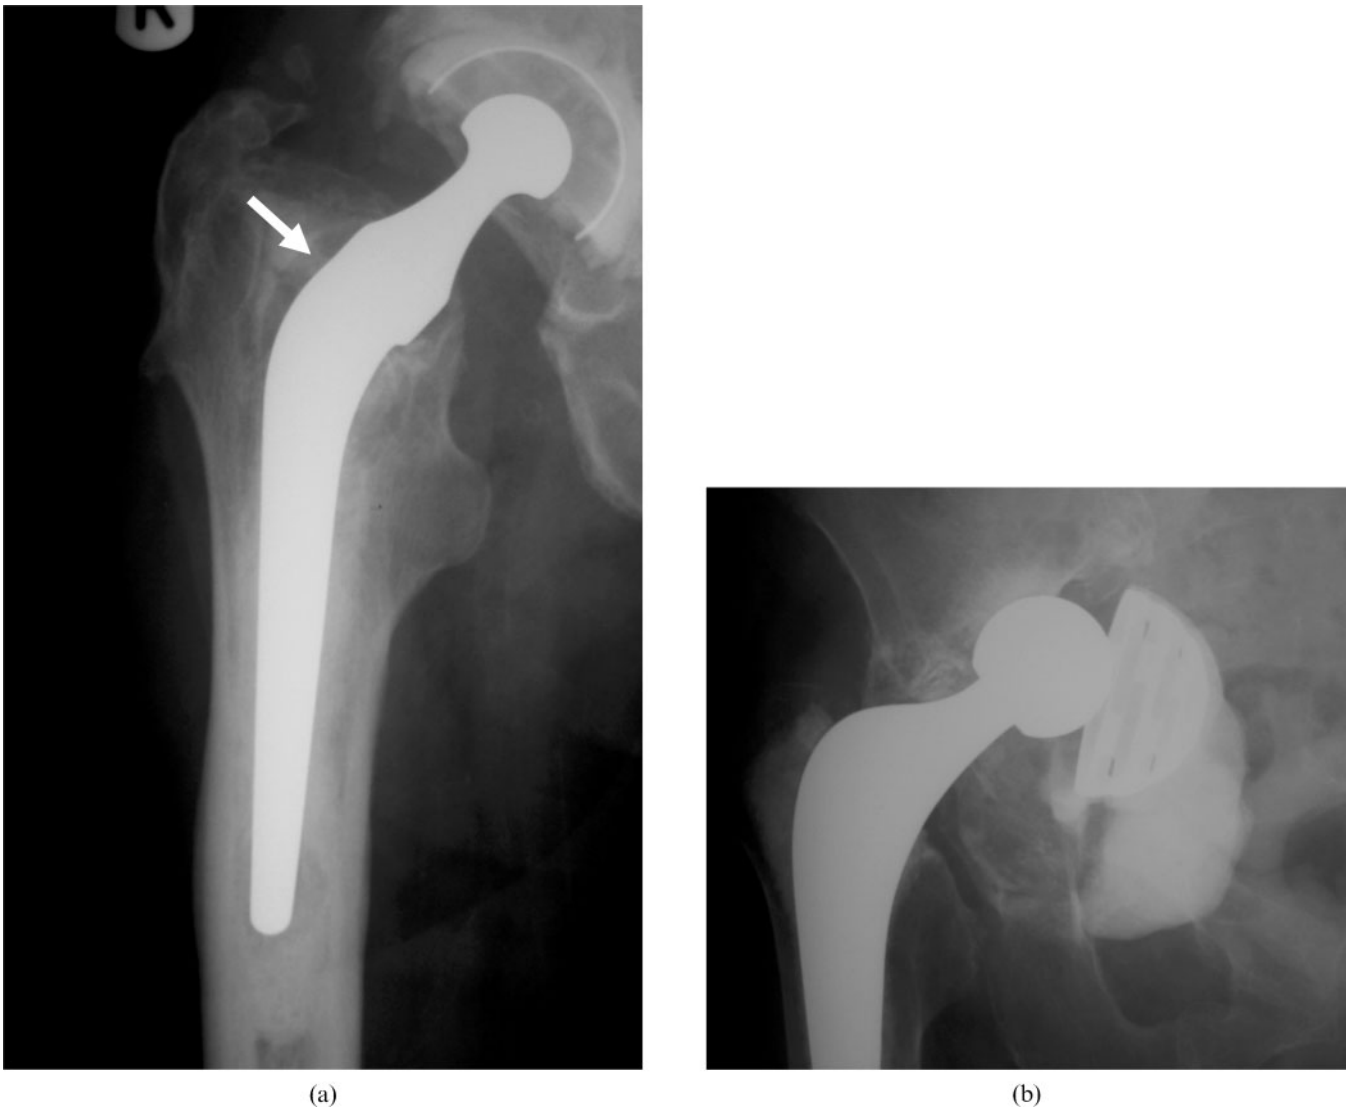
Figure 5. Migration of the prosthesis. (a) Femoral component showing subsidence with wide lucency at the prosthesis cement interface proximally and laterally (arrow). (b) Acetabular migration. The cup and cement has migrated medially into the pelvis.

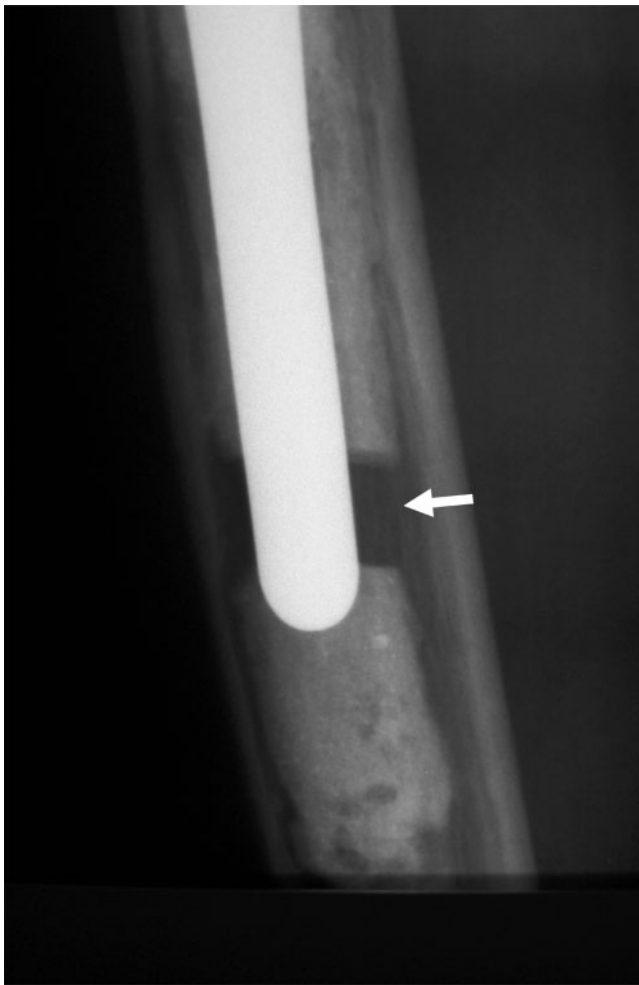
Figure 6. Loose femoral component. There is a fracture of the cement around the distal end of the femoral component indicating loosening.

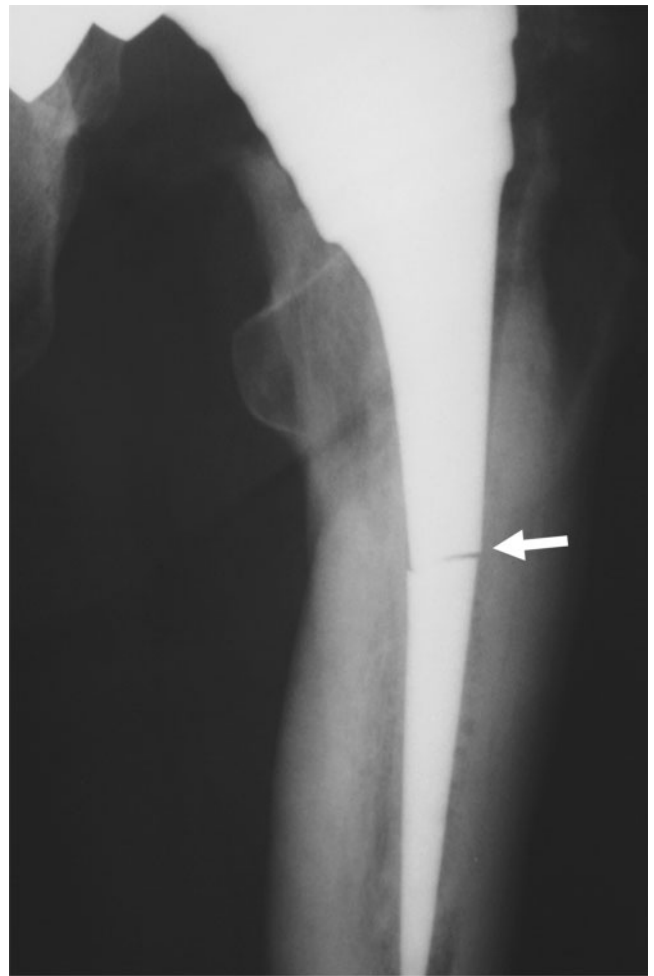
Figure 7. Loose femoral component. There is a fracture of the prosthesis (arrow).

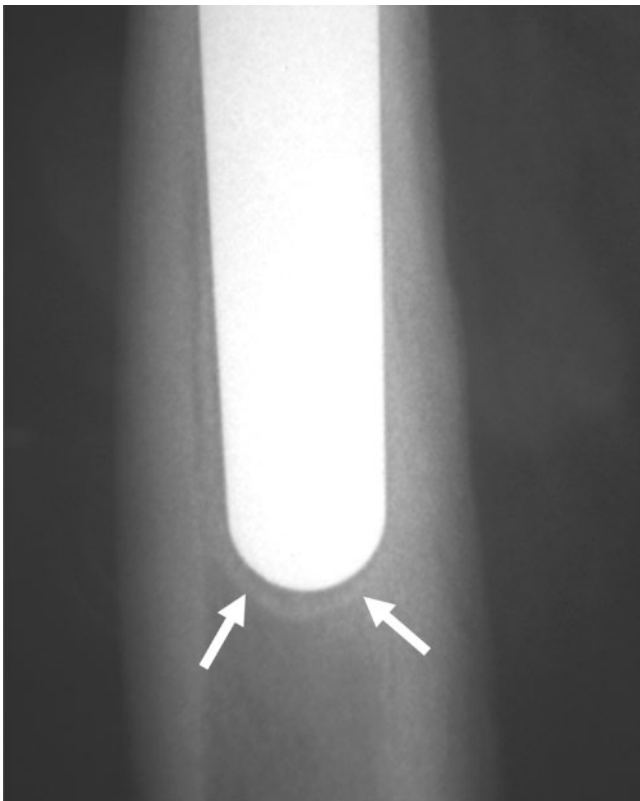
Figure 8. Loose uncemented femoral component. There is excessive lucency seen around the tip of the uncemented prosthesis indicating loosening (arrows).

prosthetic failure include a radiolucent line greater than 2 mm in width, progression of lucencies and the appearance of new lucency after 2 years from insertion [4] (Figure 10). As progression of any lucency over a period of time is a good indicator of loosening it is important to compare the current film with previous radiographs. As with the cemented variety any excessive migration also is indicative of loosening.

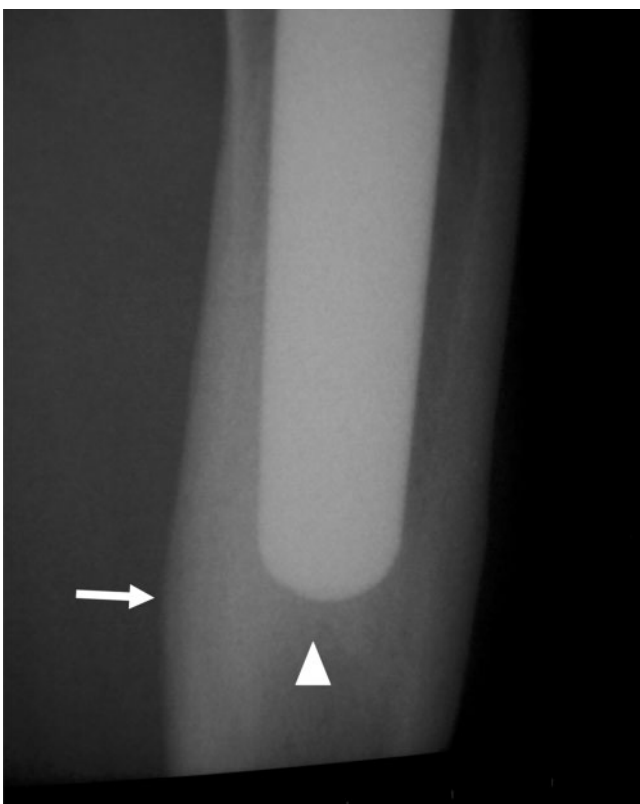
Figure 9. Uncemented femoral component. Cortical thickening (arrow) and pedestal formation (arrowhead) at the tip of an uncemented femoral prosthesis. Although associated with loosening these signs can be seen in asymptomatic hips.

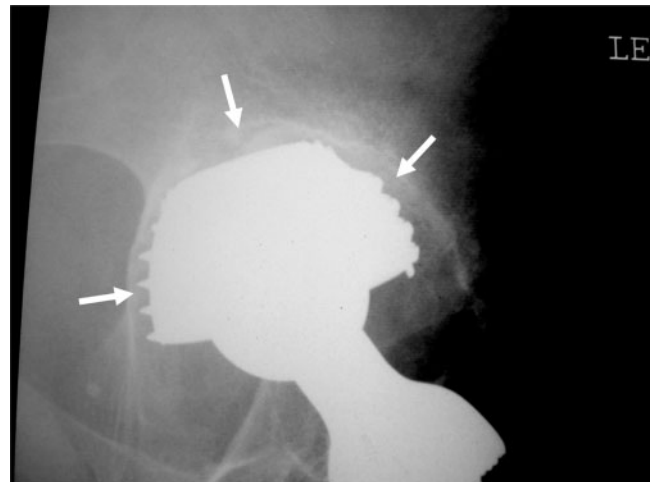
Figure 10. Loose uncemented acetabular component. This threaded screw design had a high failure rate. There is extensive lucency around the component (arrows).

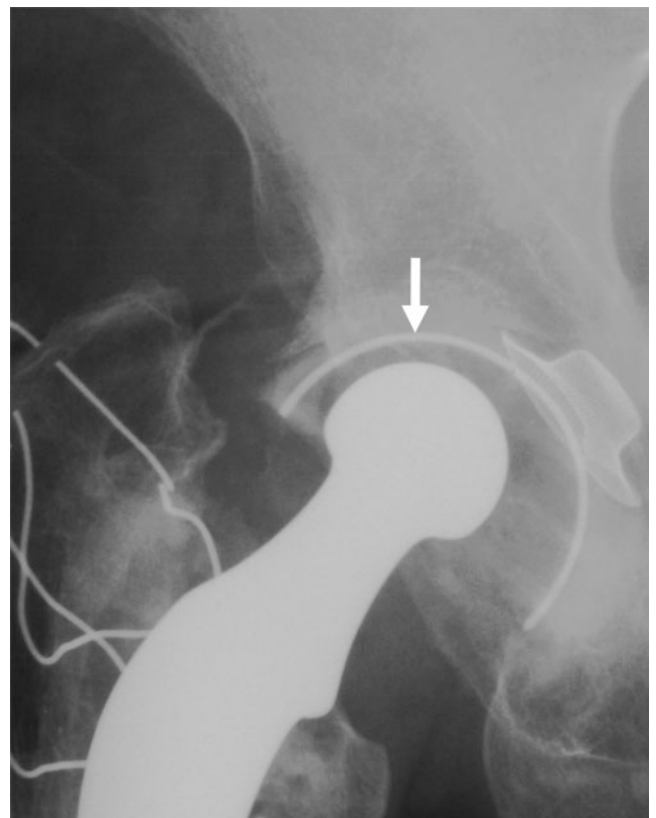
Figure 11. Wear of polyethylene liner. There is marked loss of the liner superiorly (arrow). The resulting microscopic fragments may stimulate granuloma formation.

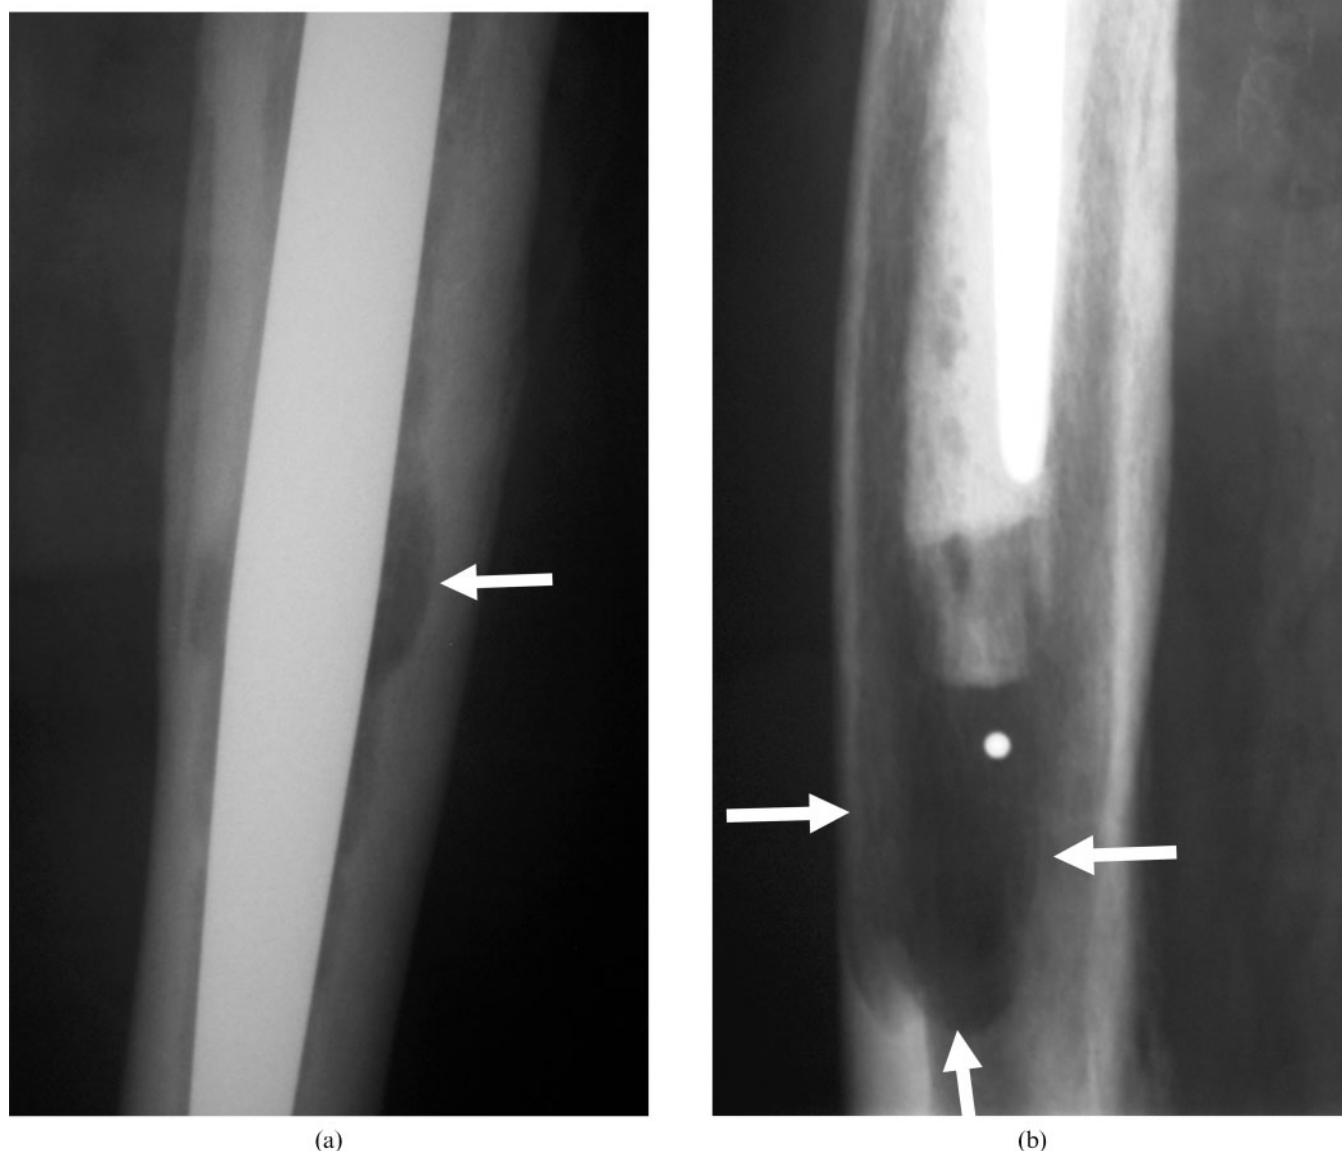
Figure 12. Granuloma formation. (a) Focal endosteal scalloping at the distal end of the prosthesis indicating histiocytic granuloma formation (arrow) and (b) more extensive bony destruction distal to the tip of the femoral prosthesis (arrows).

Another feature indicating impending failure in both cemented and uncemented prostheses is focal osteolysis. This is due to granuloma formation as a response to microscopic particles of cement, polyethylene or metal. Wear of the polyethylene acetabular cup is thought to be a common cause of this complication (Figure 11). Osteolysis is usually seen as focal endosteal scalloping at the femoral site or bone destruction under the acetabular component. Massive osteolysis with soft tissue mass may occur [5] (Figure 12).

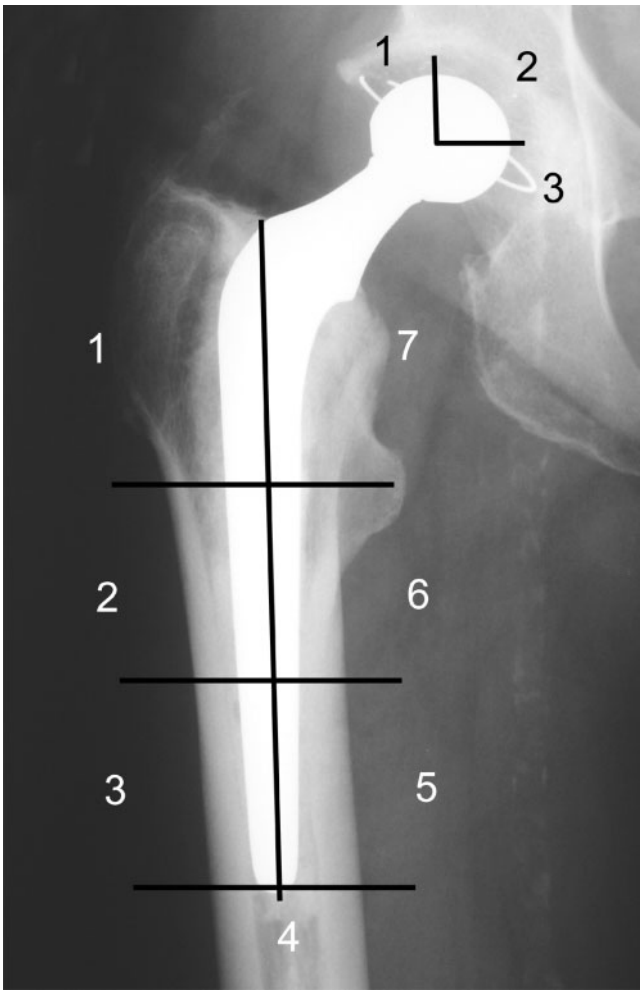
Figure 13. The seven femoral and three acetabular zones as described by Gruen and Delee [6, 7].

There is a recognised convention for describing the position of periprosthetic lucencies (or any other abnormality) that divides the acetabular component into 3 zones and the femoral into 7 zones [6, 7] (Figure 13).

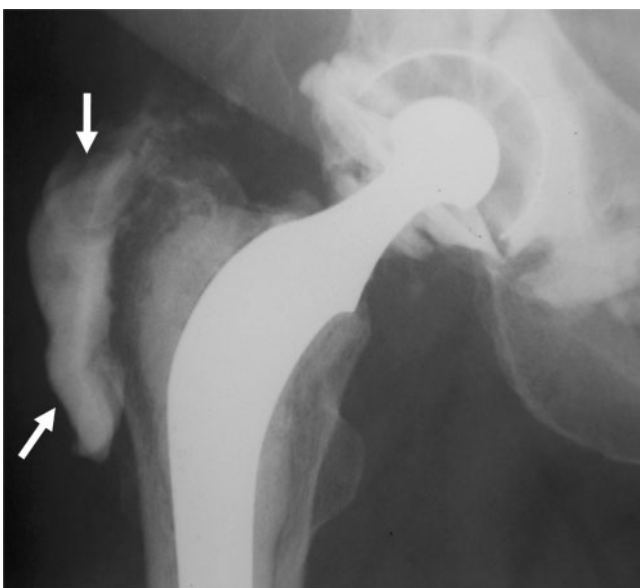
Figure 14. Arthrogram showing communication with the trochanteric bursa (arrows).

techniques can be used to increase the sensitivity. Unfortunately the test does not add significantly to the plain film findings for the femoral component [8] and is non specific for the acetabular component [9]. Positive results are seen in patients without pain and false negative results are common. Communication with the trochanteric bursa, which is common, further reduces sensitivity as a good intra-articular pressure cannot be established (Figure 14).

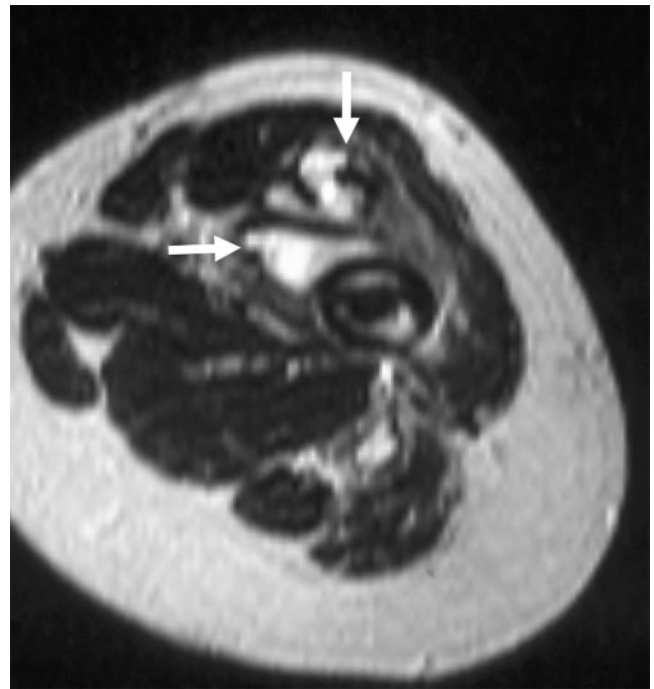
Figure 15. MRI of periprosthetic abscess. T_2 weighted axial image showing a high signal collection adjacent to the femur (arrows). Note that there is only minimal artefact from the prosthesis.

Ultrasound and MRI are useful in assessing the extent of any soft tissue abscess although metal artefact will obscure the image near the prosthesis on MRI (Figure 15). On ultrasound infection should be suspected if there is a large joint effusion with or without extra-articular extension of fluid [14].

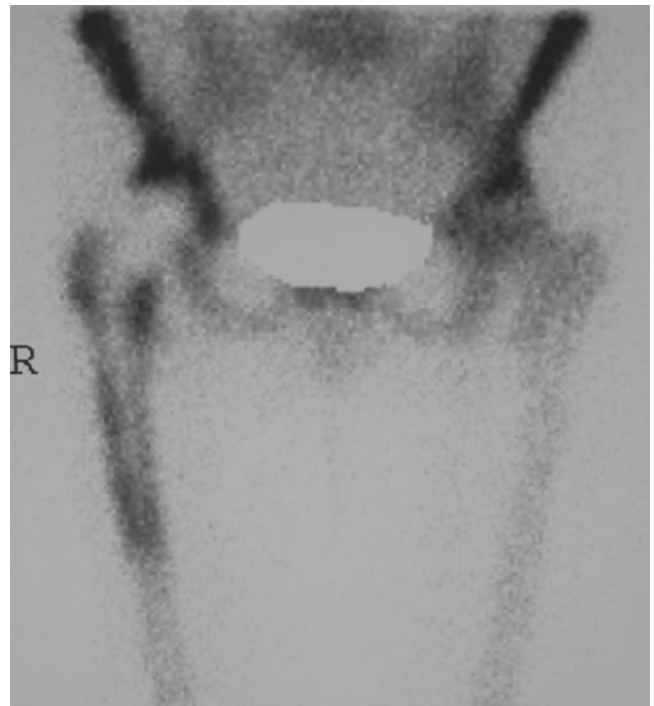
Figure 16. Bone scan showing diffuse uptake around the femoral prosthesis. Although this pattern may suggest infection it is also seen in aseptic loosening.

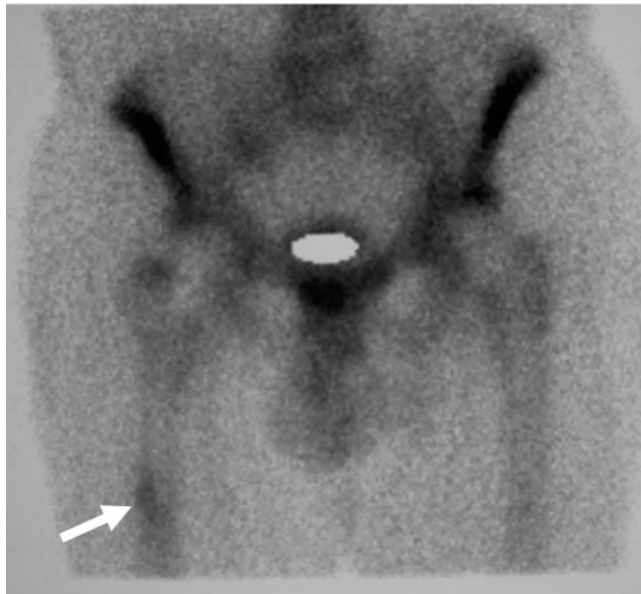
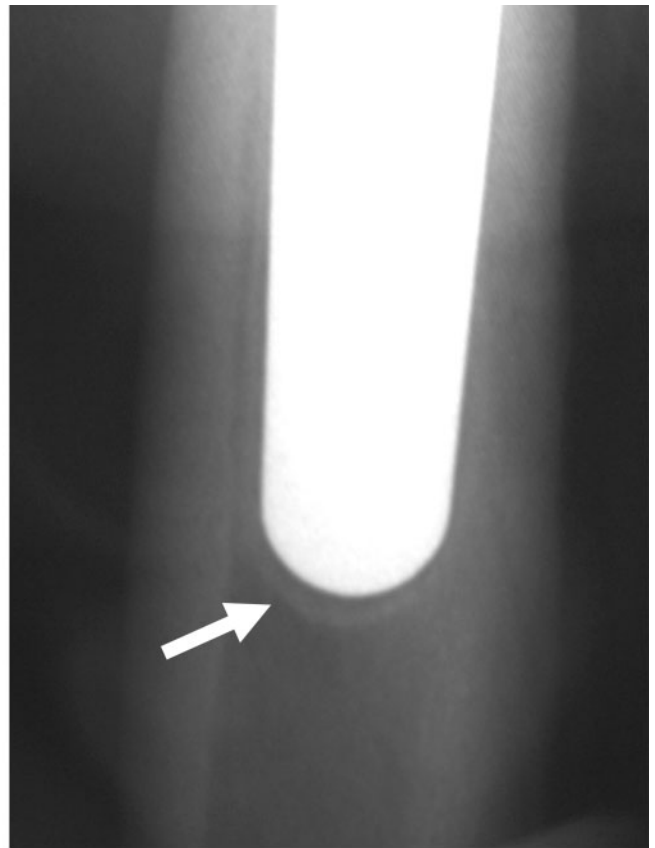
Figure 17. Bone scan in a patient with a painful uncemented total hip replacement. (a) There is focal uptake at the tip of the uncemented prosthesis. (b) Plain film shows a lucency and sclerotic reactive line adjacent to the tip (arrow).

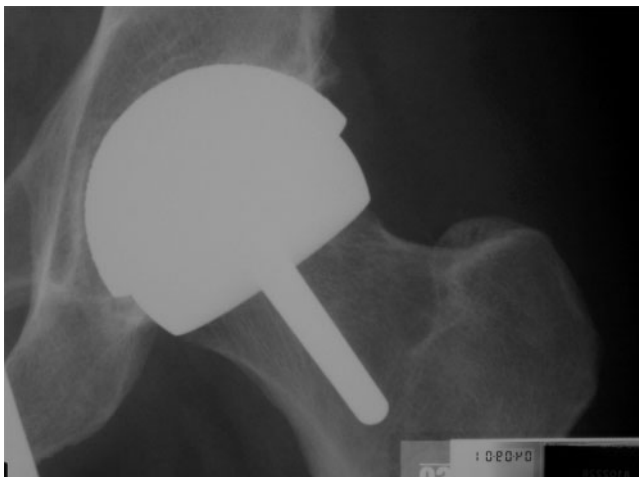
Figure 18. Normal appearances of a metal-on-metal surface replacement.

Loosening, infection and osteonecrosis are complications that may be seen in the surface replacements. In the past surface replacements have had a high rate of loosening due to the excessive wear of the polyethylene liner so modern designs have a metal acetabular socket (Figure 18).

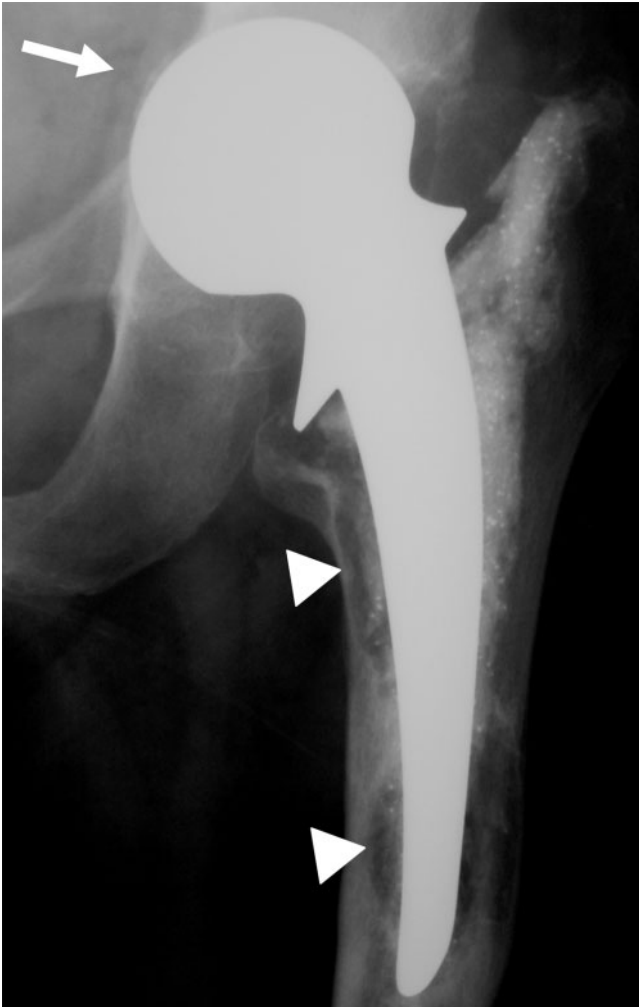
Figure 19. Failed hemiarthroplasty. The head has migrated medially into the pelvis (arrow). There is also lucency at the cement–bone interface (arrow heads).

Femoral hemiarthroplasty used in the elderly with intracapsular fractures usually out-survive the patient. However, wear of the native acetabulum may occur in active patients and conversion to total hip replacement may be indicated (Figure 19).

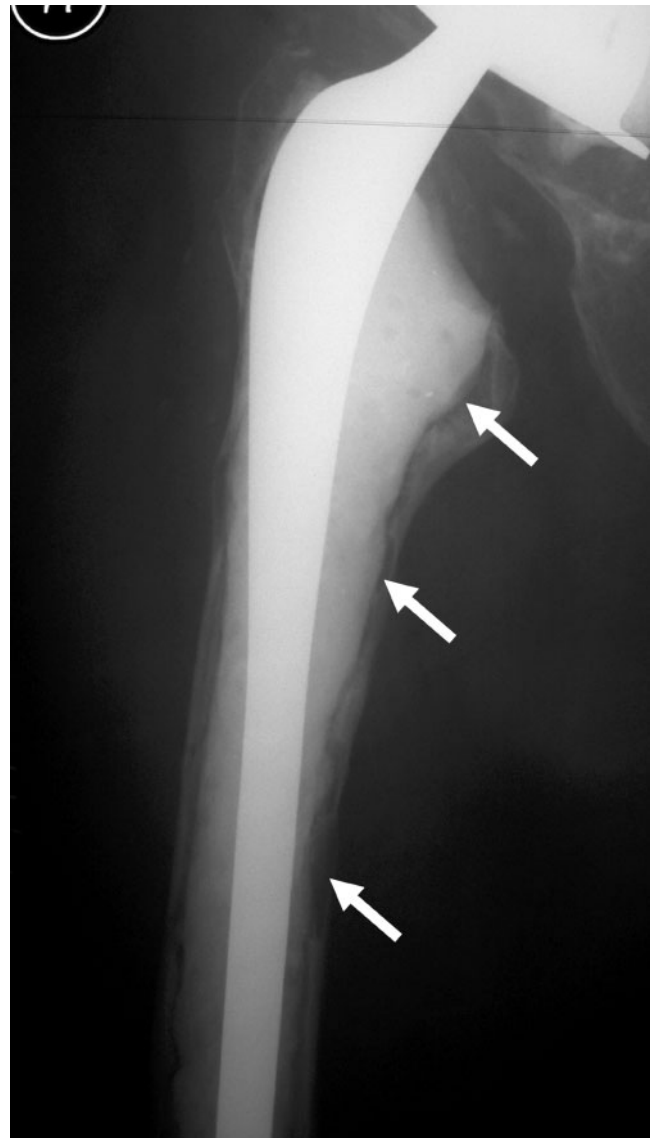
Figure 20. Revision total hip replacement. There is a wide lucency around the femoral component (arrows) which may be a normal appearance following revision.

Assessment of revision prostheses poses further problems as residual radiolucent zones are common. The diagnosis of loosening has to be made by comparing the width and extent of the lucent zones on serial radiographs (Figure 20).

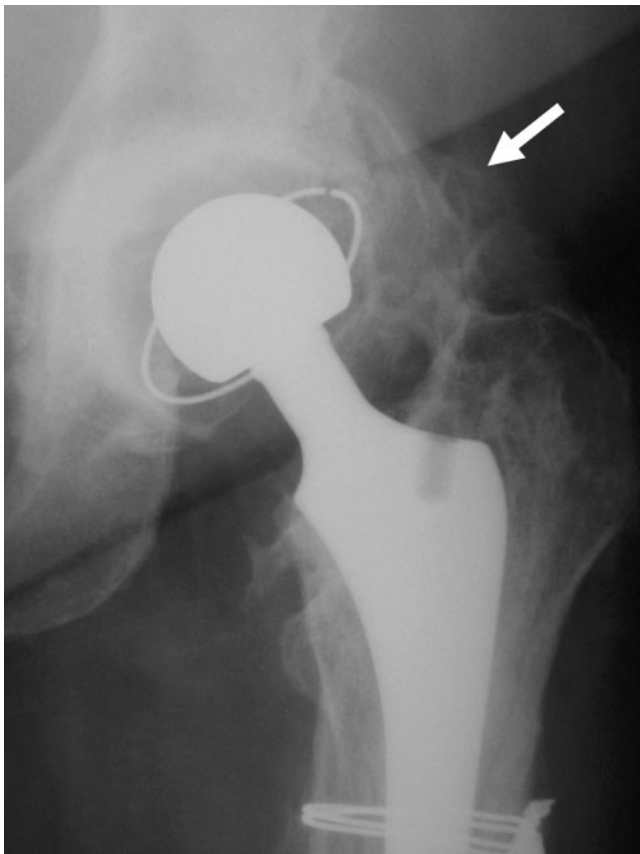
Figure 21. Heterotopic ossification following total hip replacement. There is extensive soft tissue ossification laterally which has fused the hip joint (arrow).

A complication that may affect any type of prosthesis is periarticular heterotopic ossification. Patients with ankylosing spondylitis, diffuse idiopathic skeletal hyperostosis (DISH) and hypertrophic osteoarthritis are at higher risk [20]. Although minor ossification may be of no clinical significance, extensive ossification may result in

reduced range of movement and even fusion of the joint (Figure 21).

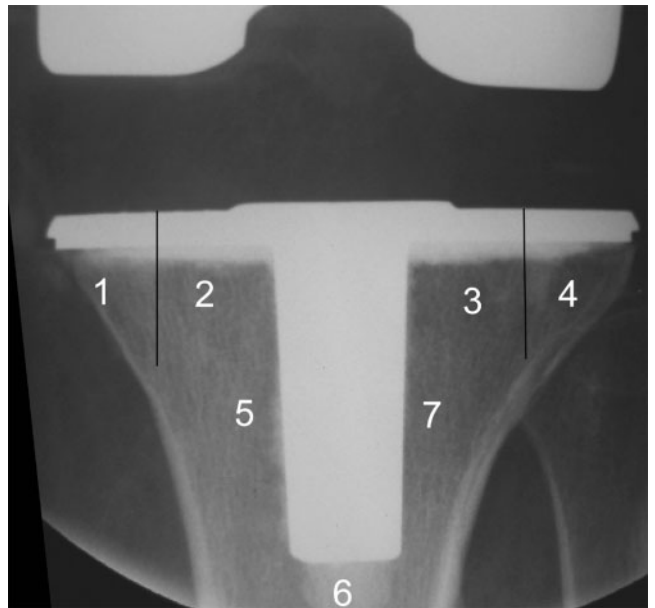
Figure 22. The seven zone of the tibial component used by the Knee Society scoring system.

Society. The score for a component is the sum of the maximum width of lucency for a given specified zone (Figure 22). For the commonly affected 7-zone tibial component a score of greater than 10 implies impending failure whereas a score of less than 4 without progression can be regarded as not significant [21] (Figure 23). Areas of ill defined bony resorption suggest infection (Figure 24).

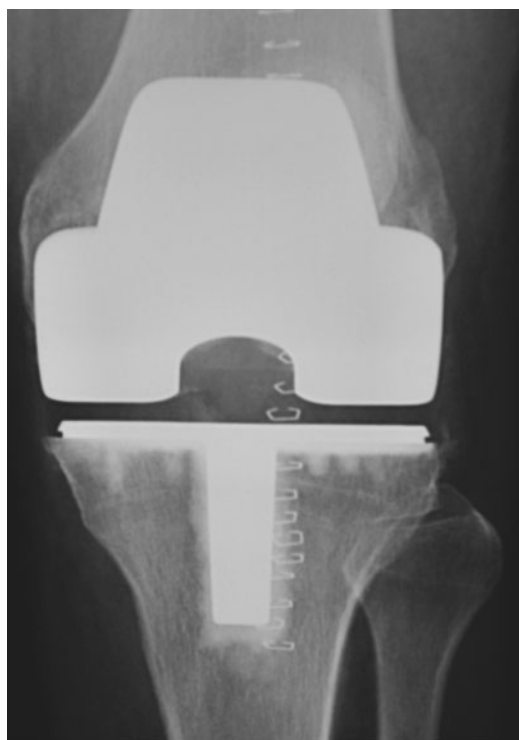
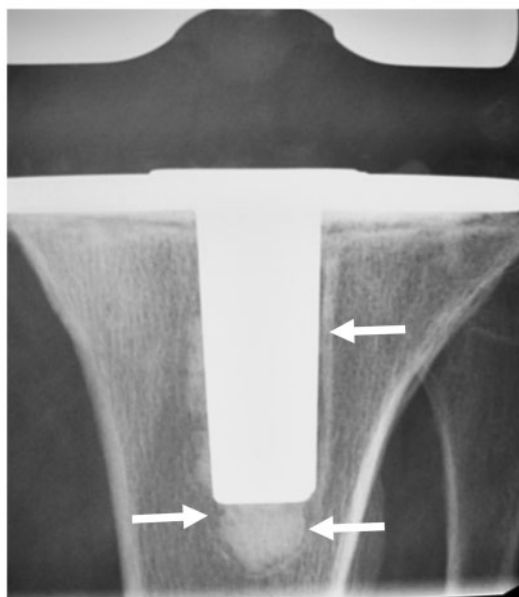
Figure 23. Aseptic loosening of a total knee replacement. (a) Normal immediate post-operative film. (b) 3 years following surgery there is a wide radiolucency under the tibial plate and around the stem at the bone/cement and prosthesis/cement interfaces (arrows).

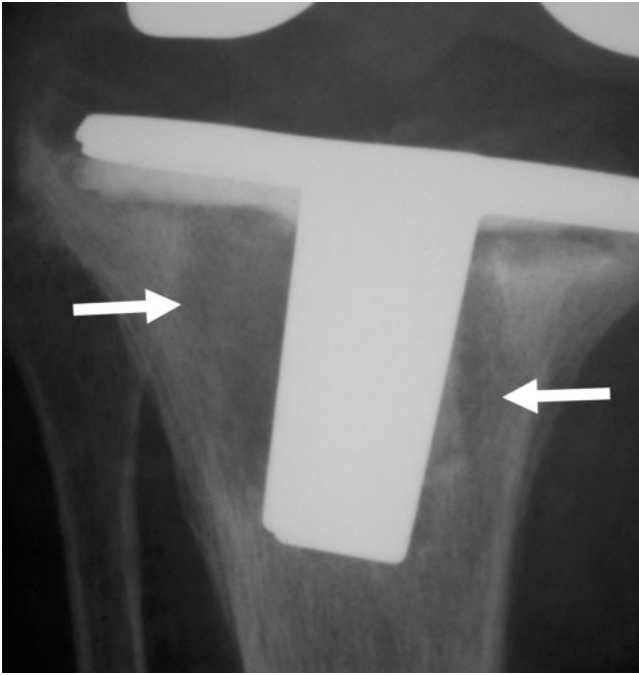
Figure 24. Infected total knee replacement. There is extensive bony destruction around the tibial component (arrows).

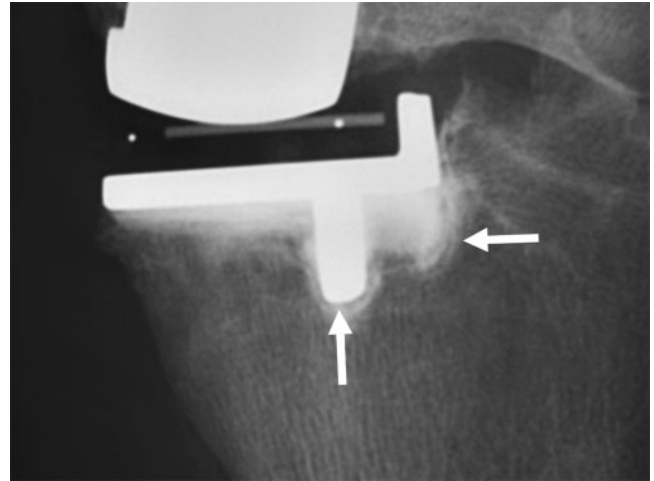
Figure 25. Unicompartmental knee replacement. There is lucency at the bone/cement interface of the tibial component which is within normal limits for this particular design.

view or MRI. The signs of loosening and infection are similar to those seen in total knee replacements except that lucency around the tibial component of the commonly used Oxford prosthesis is a normal finding (Figures 25 and 26).

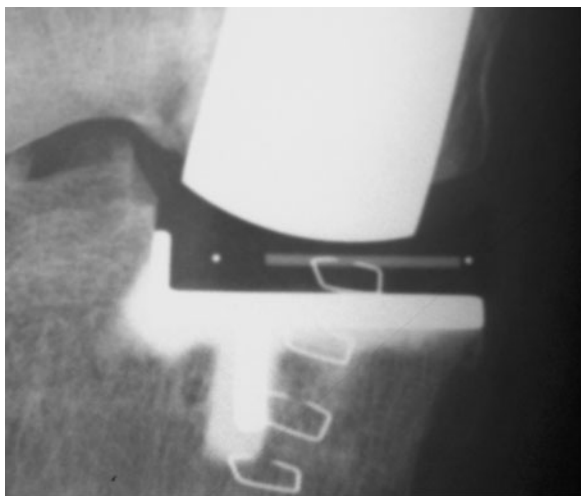
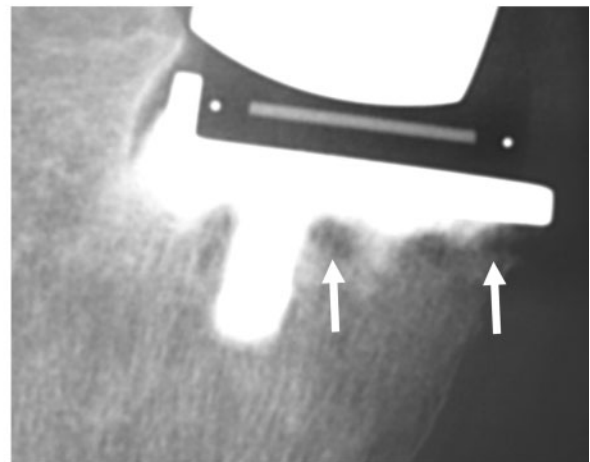
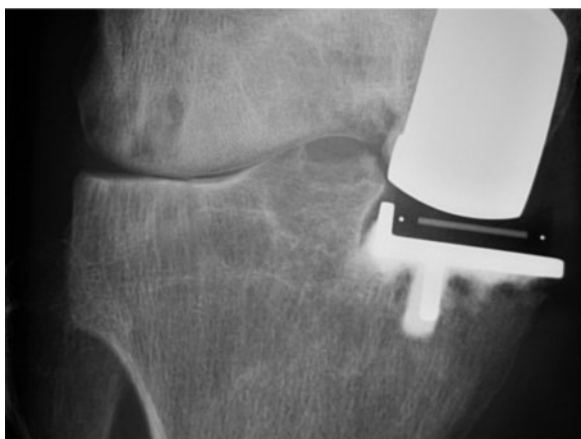
Figure 26. Infected unicompartmental knee replacement. (a) The immediate post-operative pictures show normal replacement. (b) 1 month later there is bone destruction under the tibial plate (arrows) and (c) loss of lateral joint space.

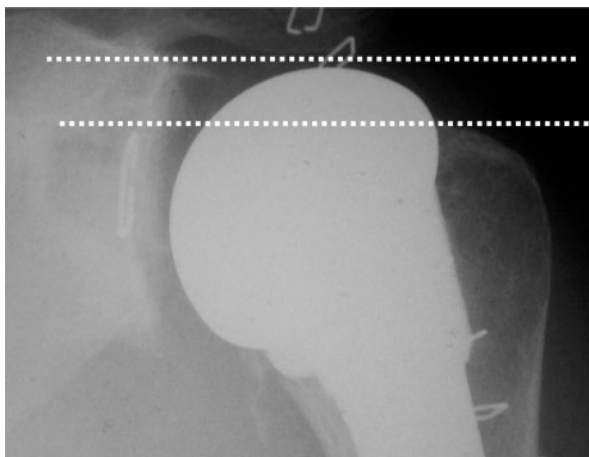
Figure 27. Normal post-operative appearance of a total shoulder replacement. The superior end of the humeral component lies above the superior tip of the greater tuberosity (dotted lines).

The main complications are loosening, infection and fracture. The glenoid component is particularly prone to loosening. An additional complication specific to the shoulder joint is that of impingement which may be due to poor positioning of the humeral prosthesis or subsidence. Impingement may occur if the most superior aspect of the prosthesis lies below the level of the superior tip of the greater tuberosity (Figures 27 and 29).

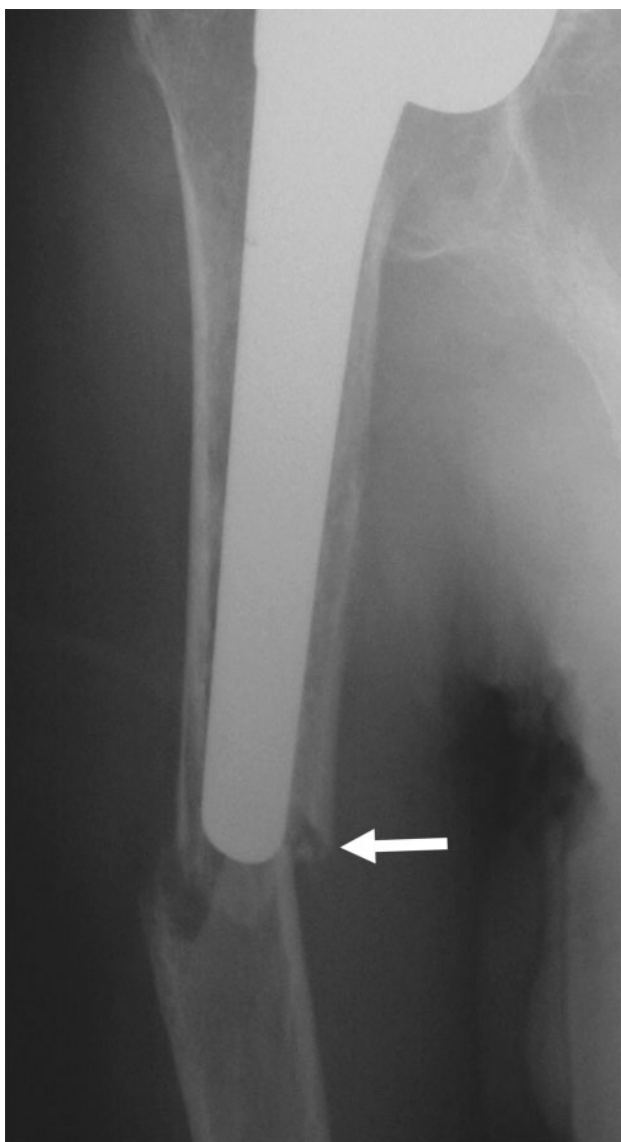
Figure 28. Periprosthetic fracture at the tip of the humeral component (arrow).

Periprosthetic fractures are usually obvious, and may occur at the time of surgery or following injury (Figure 28).

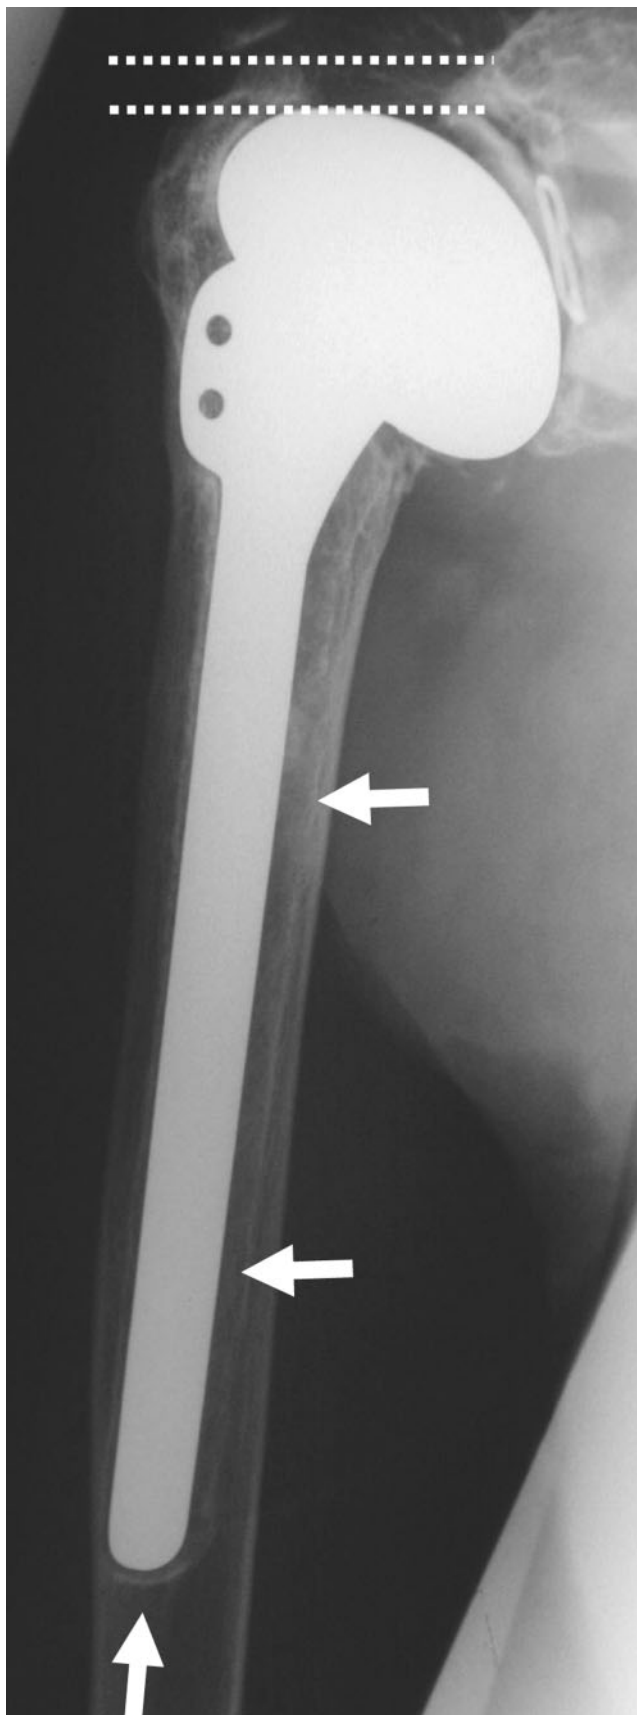
Figure 29. Loose total shoulder replacement. There is subsidence with the head positioned below the superior tip of greater tuberosity (dotted lines). There is a wide lucency seen around the prosthesis (arrows).

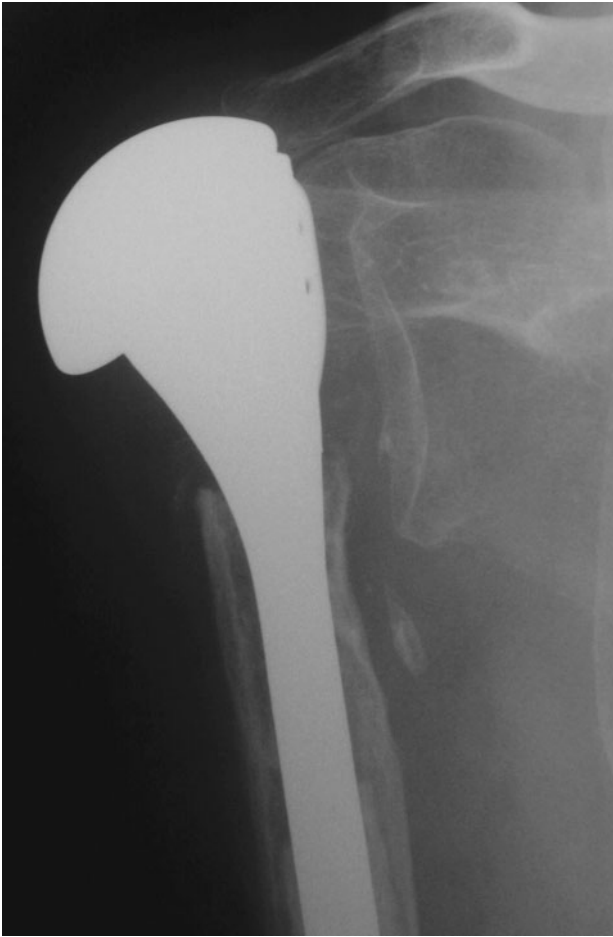
Figure 30. Displacement of humeral component of total shoulder replacement. The component is loose and has rotated approximately 180°.

For the humeral component the criteria for loosening are similar to those used for the hip with periarticular lucency, subsidence and displacement being the key features (Figures 29 and 30). Lucency at the glenoid is harder to interpret. Lucency is often seen here on the immediate post operative film which is thought to be due to insufficient preparation of the bone bed. Reliable signs of loosening of the glenoid component are progressive periprosthetic lucency and migration (Figures 31 and 32). The rate of glenoid loosening is around 10% at 10 years.
