Imaging of prosthetic joints

S OSTLERE, FRCR and S SOIN, MB BChir

Nuffield Orthopaedic Centre and Oxford Radcliffe Hospital, Oxford, UK

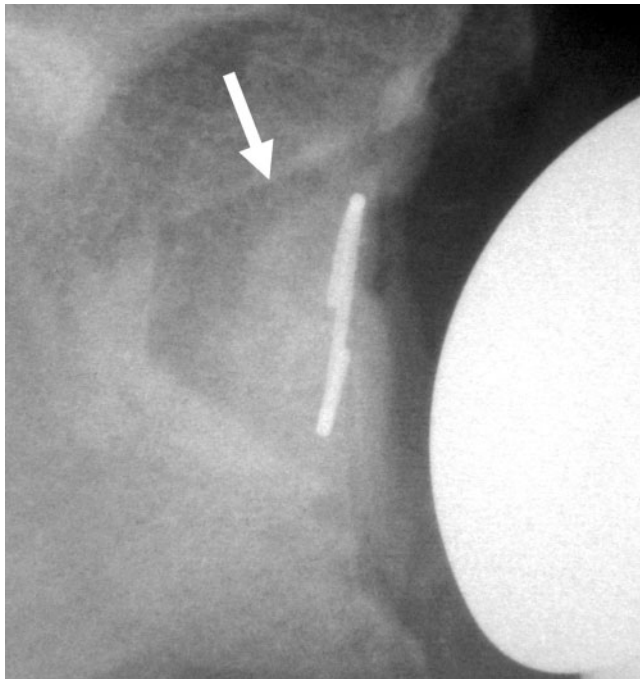
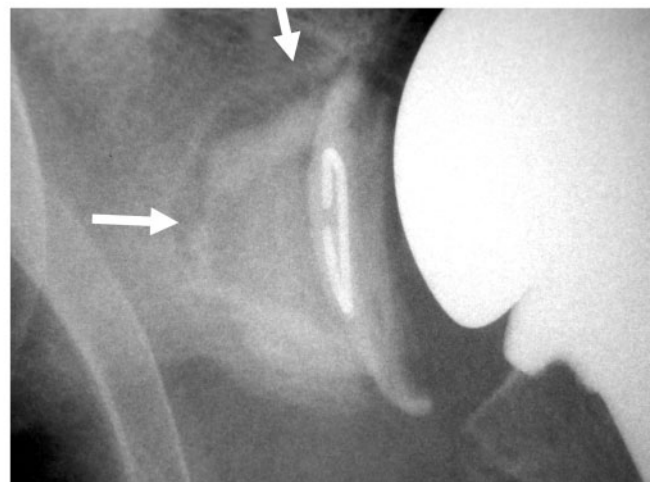
Figure 31. Loose glenoid component of a total shoulder replacement. (a) Immediate post-operative film showing normal cemented component without lucency. (b) Film 18 months later shows marked lucency around the component indicating loosening.

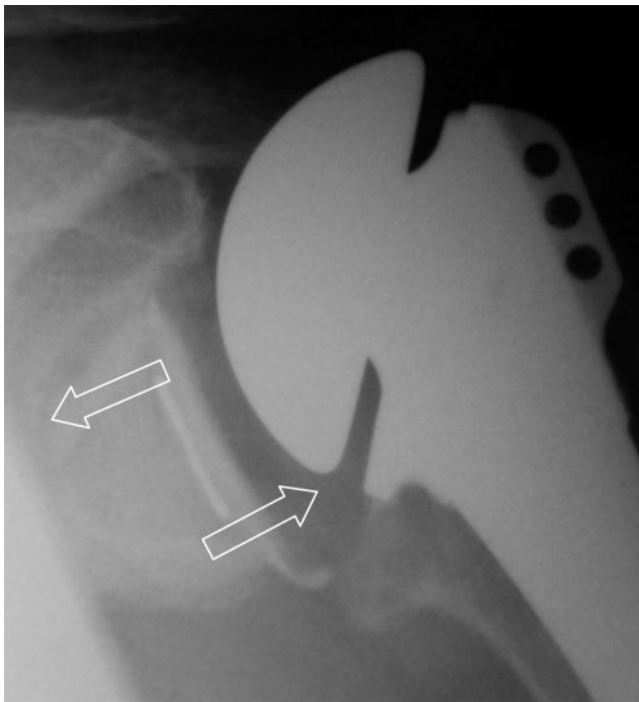
Figure 32. Loose glenoid component of a total shoulder replacement. The humeral head has migrated superiorly due to rotator cuff tear. The glenoid is loose and tilted due to the eccentric contact with the humeral component. Arrows demonstrate direction of rotation.

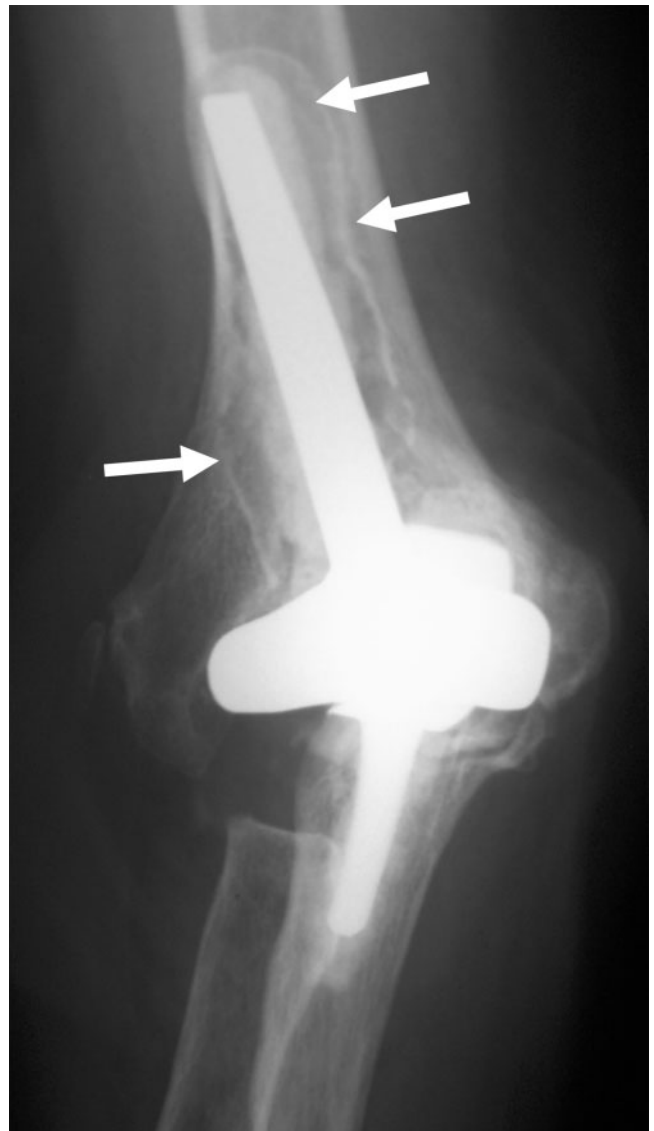
Figure 33. Loose hinged total elbow replacement. There is wide lucency around the humeral component (arrows) indicating loosening.

Generally the complication rate is higher than that for hip or knee prostheses. Intraoperative complications include condyle fractures and shaft perforation, as well as ulnar nerve damage. Loosening may predominately involve the humeral or ulnar component depending on the individual design (Figure 33) [22, 23].

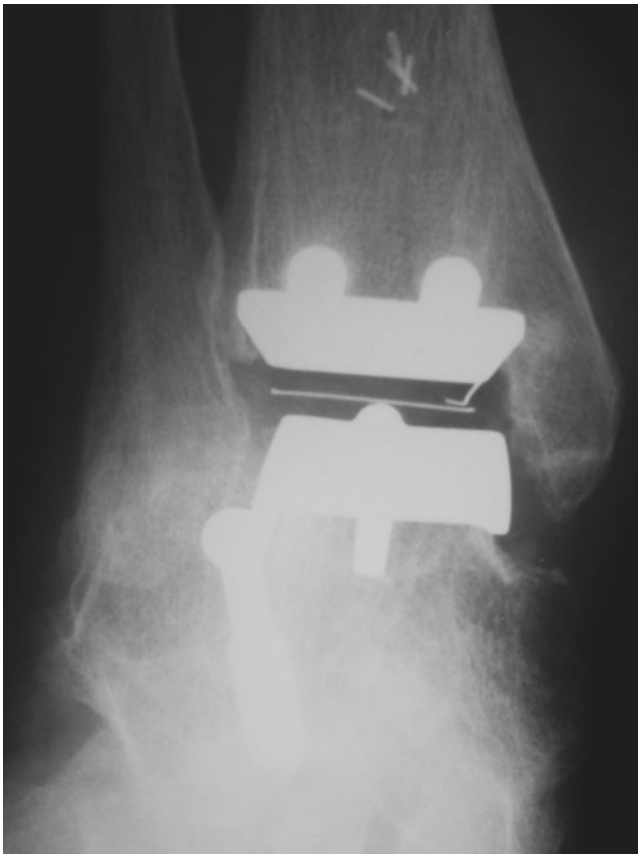
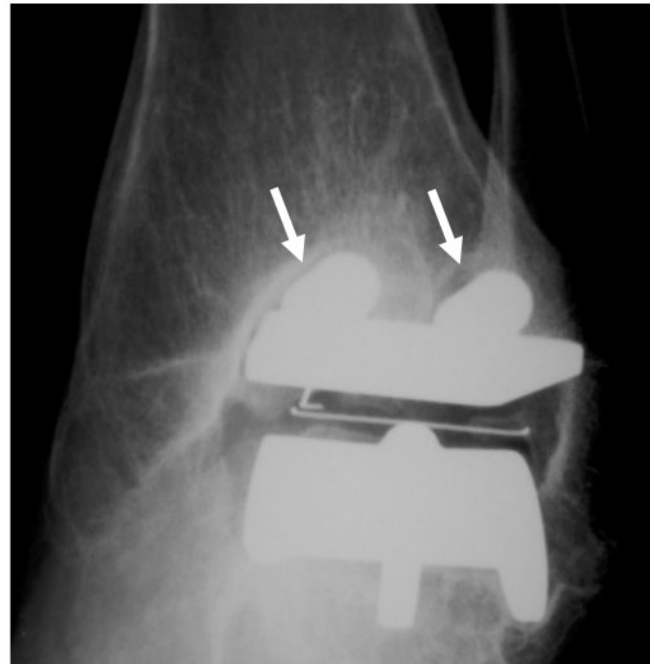
Figure 34. Loose Scandinavian Total Ankle Replacement (STAR). Frontal radiograph showing (a) the normal post-operative appearances and (b) marked lucency around the tibial component (arrows) indicating loosening.

The radiological criteria for identifying complications have not been well documented, but progressive lucency and migration are reliable signs of loosening (Figure 34). Cavity formation under the tibial component and fracture of the medial malleolus are other recorded complications (Figure 35) [25].

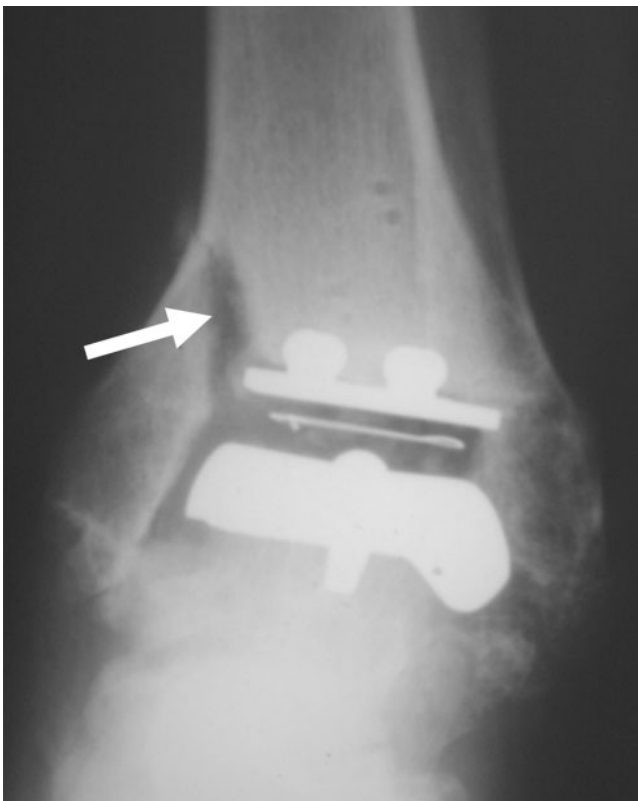
Figure 35. Total ankle replacement complicated by a fracture of the medial malleolus (arrow).
